**RE: Town of Wolfville Test Well Drilling and Step Testing Results Summary**

**Town of Wolfville  
Groundwater Supply Study**

**Town of Wolfville Well Development**

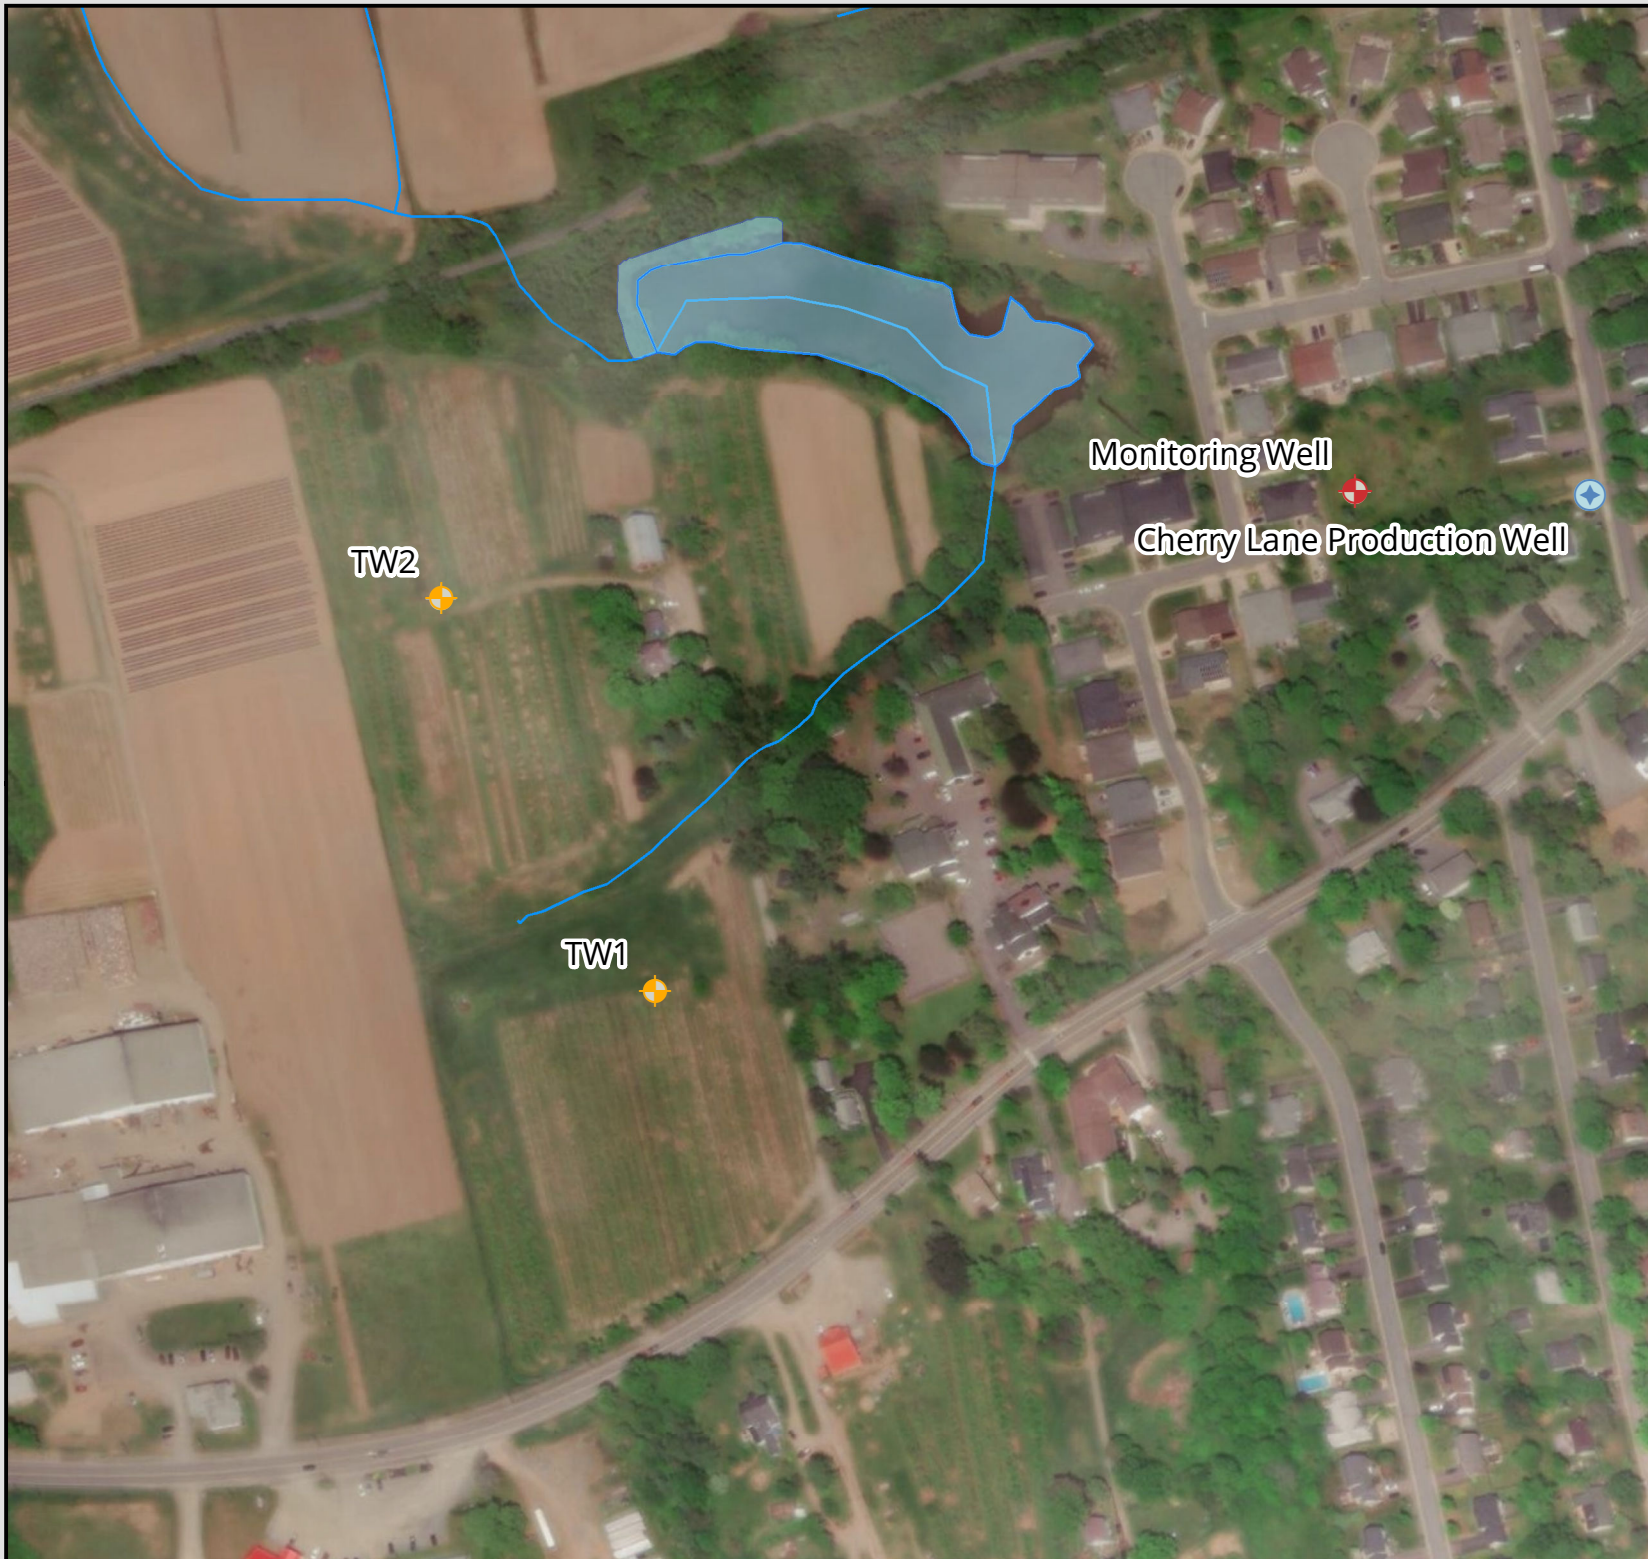
**FIGURE 1**

The locations of the test wells are shown in Figure 1. TW1 was drilled in an area of low-relief, 30 m south of a small stream that drains the property. The property owner reported that standing water can be present in this general area during and immediately after snowmelt events. The low relief at the ground surface may be associated with the deepest part of the buried outwash valley aquifer that supplies Wolfville's current production wells.

TW2 was drilled on a local ridge, 175 m north of TW1. Following the axis of the Annapolis Valley and the NSDNR mapping of the outwash aquifer, this location is aligned with the existing Cherry Lane production well. Prior to drilling it was unknown if the ridge represented an additional thickness of sand and gravel, a confining unit of till, or ridge of the Wolfville Formation.

**Test Well Locations**

A program of test well drilling and a step drawdown pumping test were completed on PID 55289524, adjacent to the western town boundary and north of Highway 1 (Figure 1). The property is occupied primarily by a fruit orchard and includes a house and barn on the eastern edge of the property. There is a ridge on the property oriented from west to east, following the approximate axis of the Annapolis Valley, and a stream that originates at the foot of the ridge, draining eastward. The northern edge of the property borders the flood plain / dikeland of the tidal Cornwallis River.

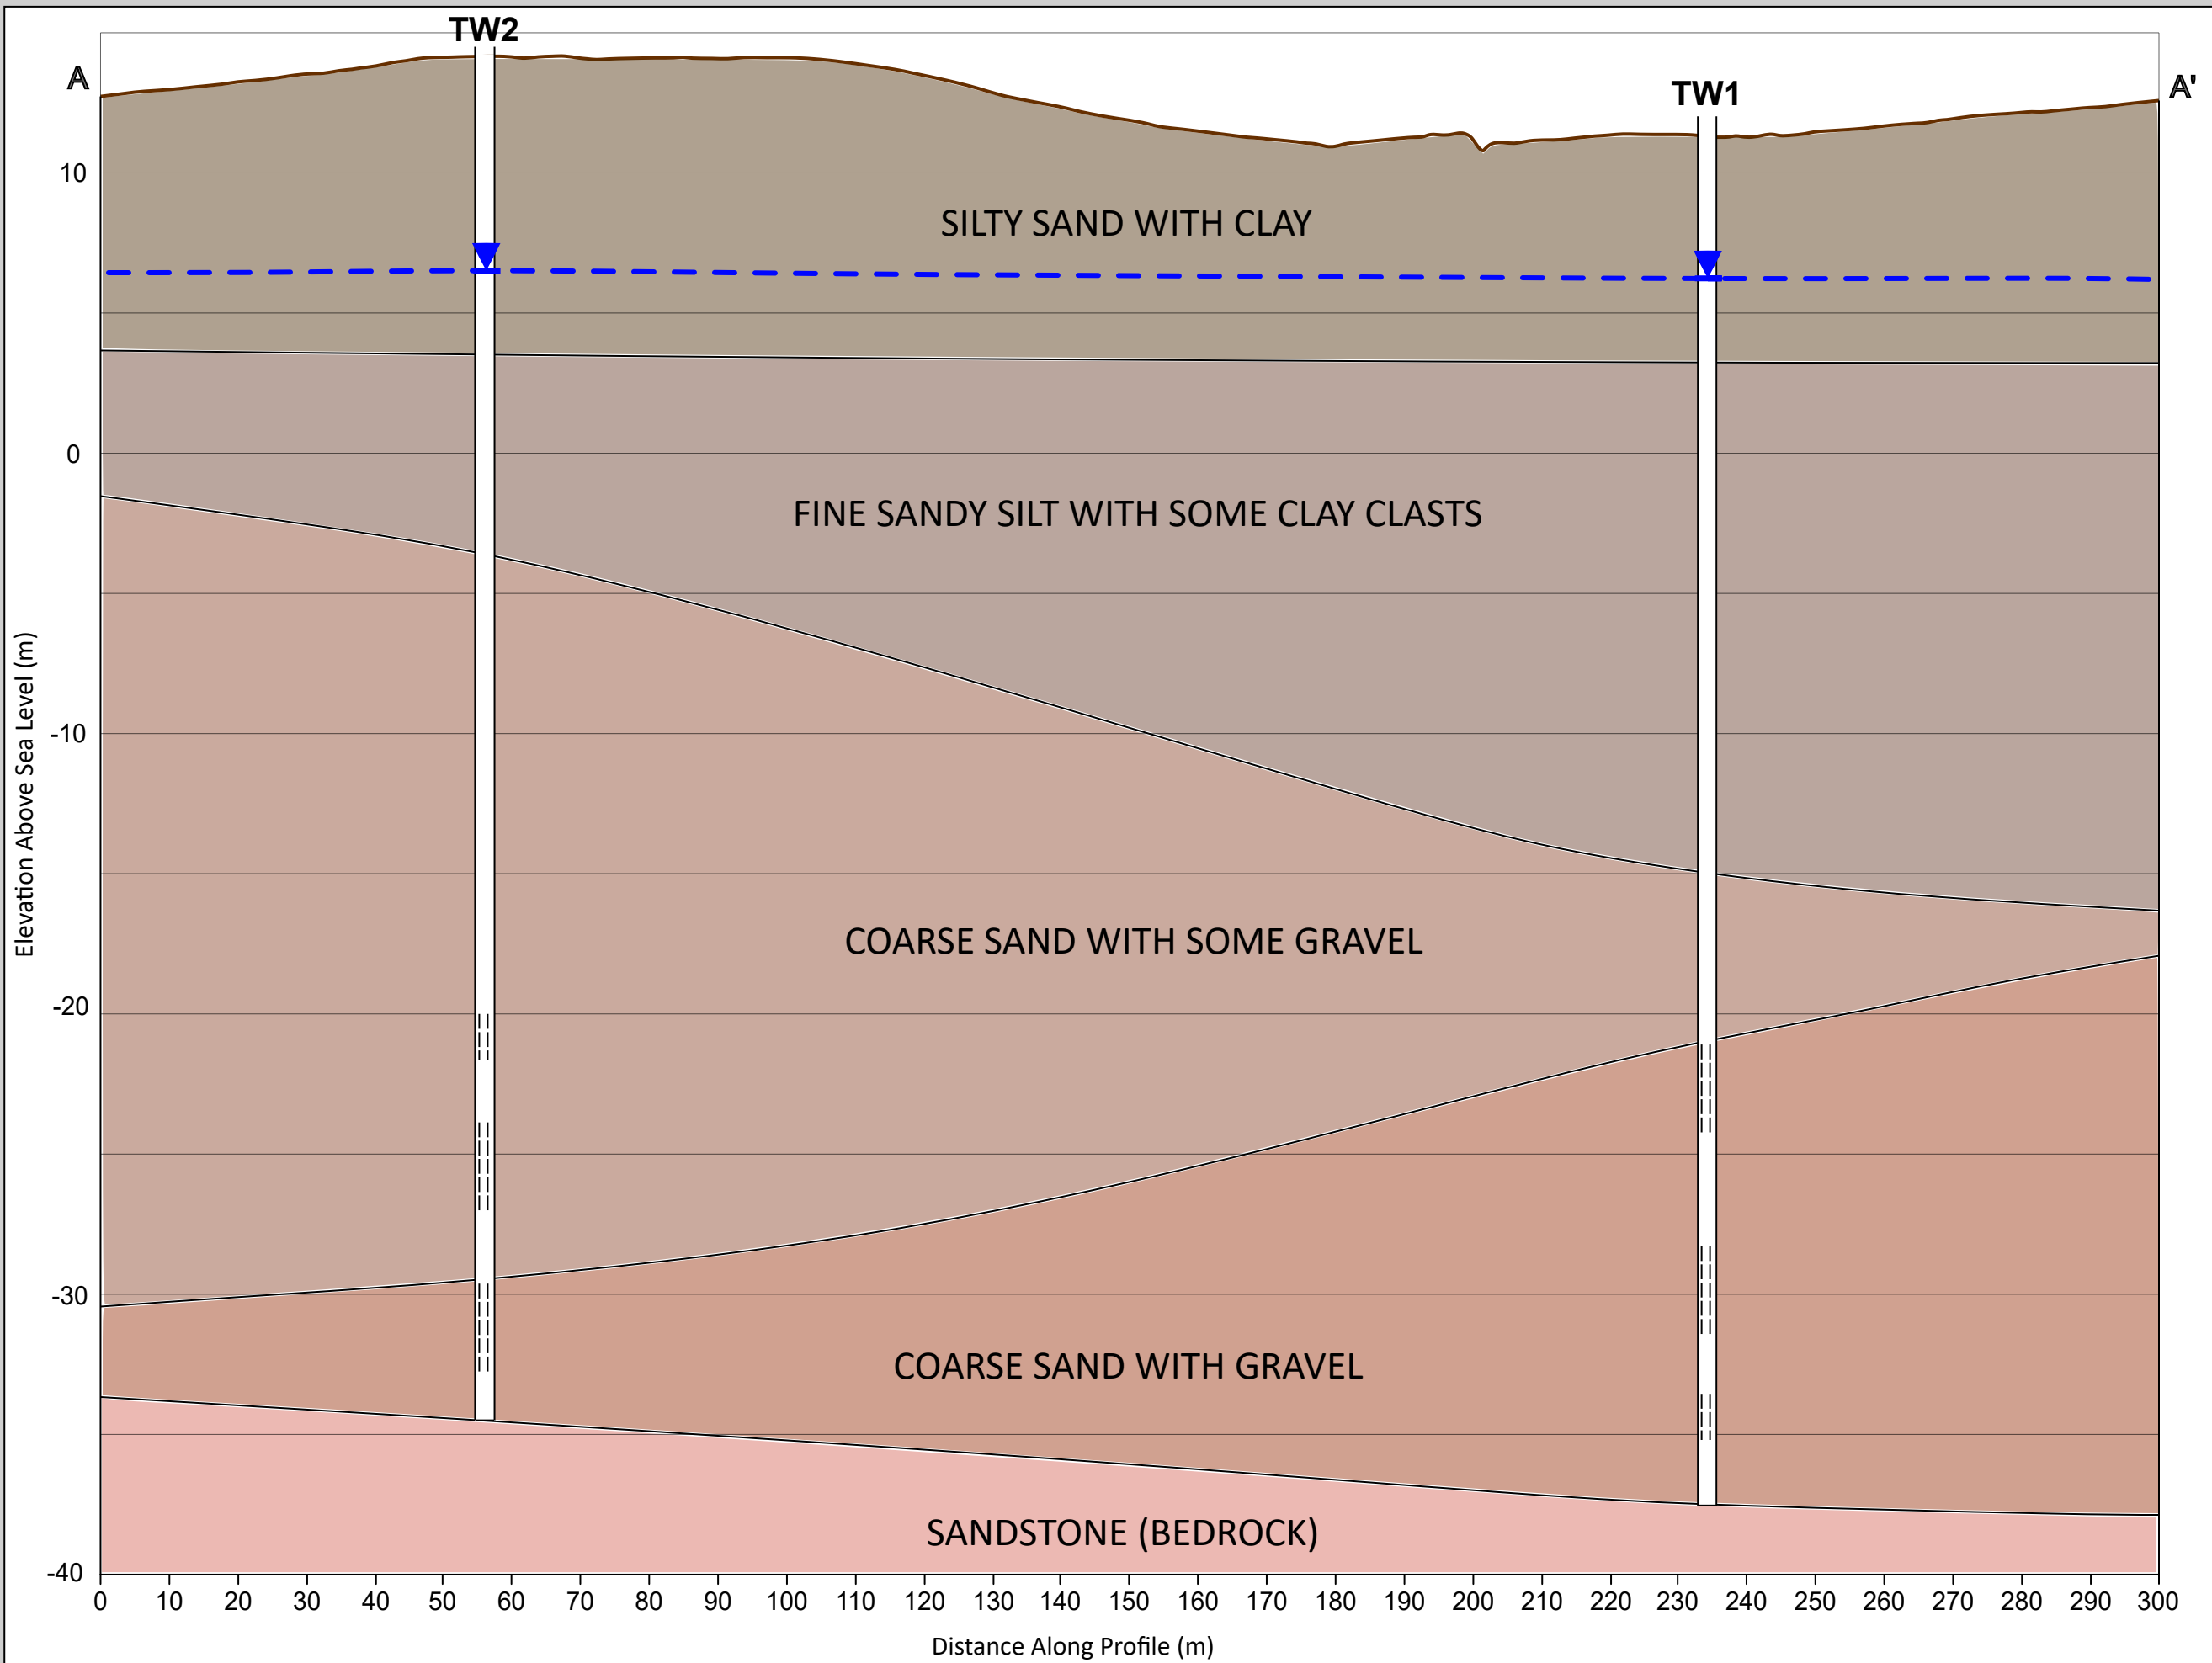
Figure 2 - Test Well Cross Section

Figure 2 shows a cross-section of the geologic sequence, interpolated between TW1 and TW2. The thickness of the deeper gravel unit appeared to increase from north to south, and the bedrock surface dipped slightly southward. A comparison of the cuttings and development water at both boreholes showed that conditions at TW1 are most favourable for well development.

Cuttings sampled from TW1 showed significant sequences of well-sorted sand and gravel with minimal fine sand and silt content, primarily at depths below 30 m. The gravel sequences were overlain by layers of silty sand with clay and silty sand with gravel. The silty material may provide a degree of confinement of the target zone of the aquifer. Cuttings samples from TW2 contained red silt and fine sand throughout the borehole profile, and generally included clasts of sandy silt. The well-sorted coarse-grained sequences encountered in TW2 were associated with silty, red water in the cuttings, and were difficult to distinguish from the poorly consolidated sequences of the Wolfville Formation observed in previous work by CBCL.

Borehole refusal was encountered at 44 m, assumed to be associated with a harder bedrock unit. Airlifted water produced by TW2 after 2 hours of development did not show a reduction in turbidity. Drilling at TW2 also included a first attempt that was aborted at 12 m due to refusal of the drill bit. Minimal cuttings were produced at this depth, but chips of granitoid material indicated that the borehole had encountered a large glacial erratic.

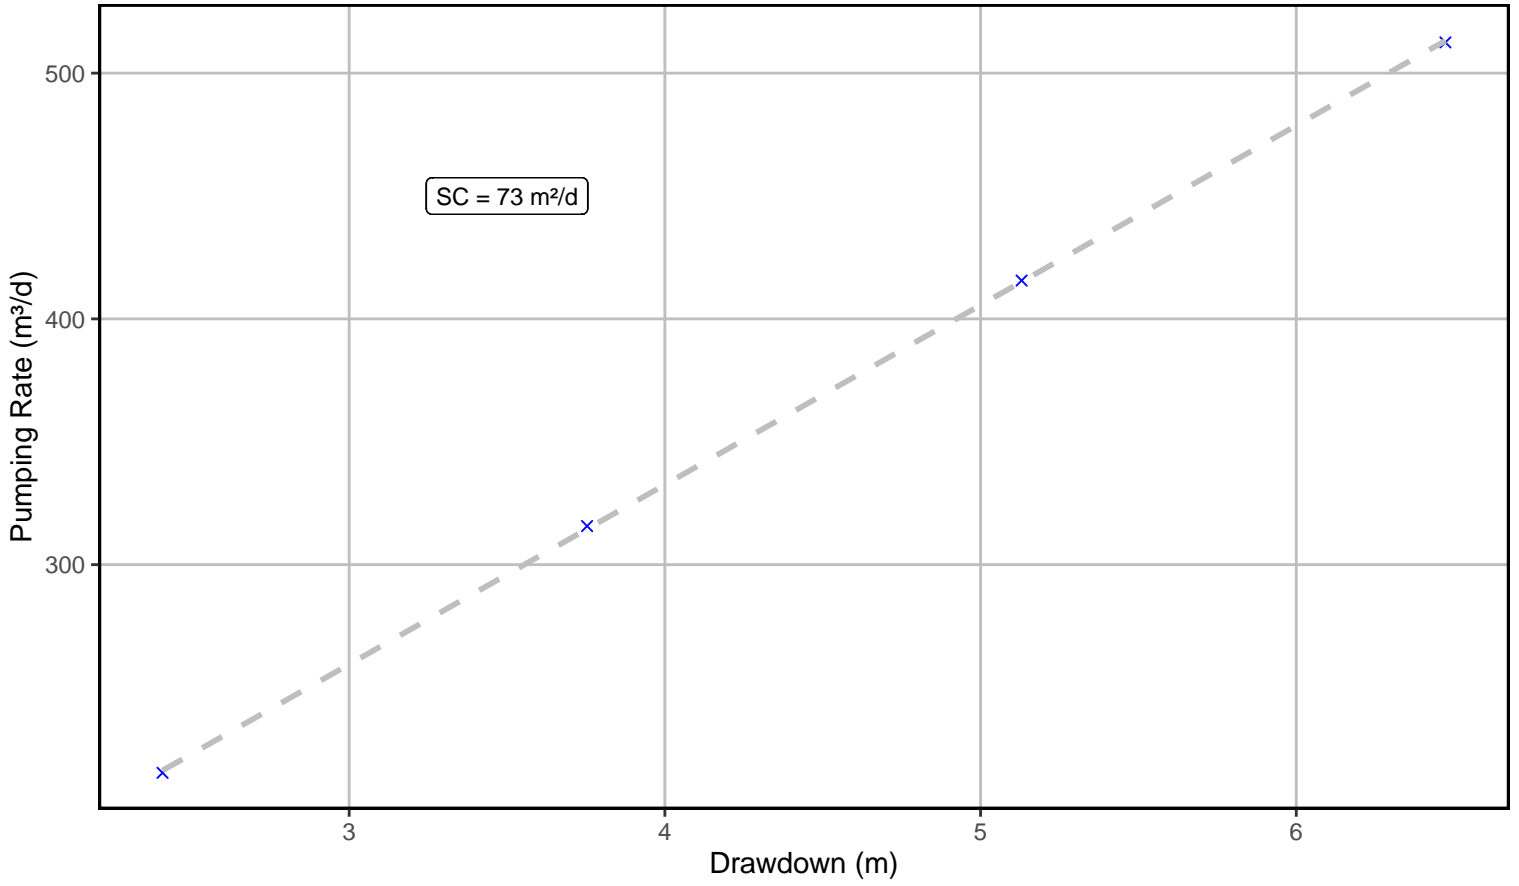
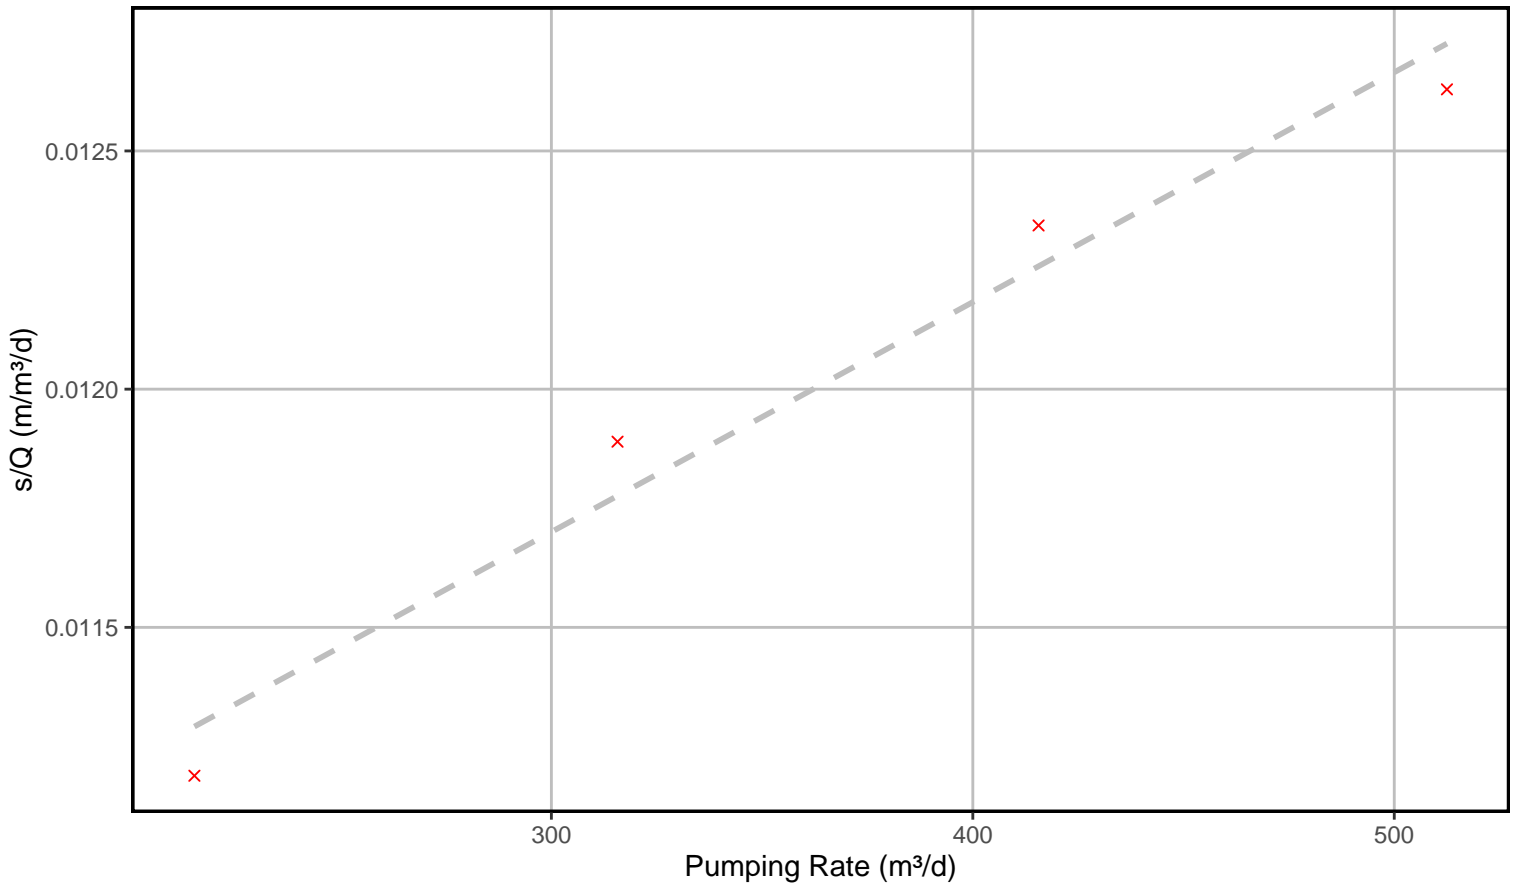
Figure 4: Aquifer Test Analysis, Step-Drawdown Analysis, Data Observed at Test Well 1, Wolfville

- ▶ The pumping rate was increased after each hour to provide preliminary indications of the well specific capacity and efficiency (Figure 4).
- ▶ The specific capacity is an indication of the yield provided per meter of drawdown.
- ▶ The well efficiency is an indication of how much drawdown is caused by losses within the well. Head losses within the well do not lead to drawdown in the surrounding aquifer, but they do affect the maximum sustainable pumping rate.
- ▶ Physical water quality parameters were recorded throughout the test (Table C2).
- ▶ A water quality sample was collected at the end of the step test, and analyzed for general chemistry and trace metals, including volatile organic compounds (VOCs) and microbiological quality (*E. coli* and total coliforms) (Table C1).

Table 3 provides a summary of step testing results. A component of the observed drawdown was related to losses within the well (< 20%). Well losses can be caused by turbulence near the borehole wall, friction in the pump and pump tubing, and a low-permeability 'skin-zone' at the borehole wall, caused by the drilling process. Well losses in this test well are likely affected by the limited intake area created by the down-hole perforator, and the limited amount of well development that can be accomplished with this type of installation. Well losses are expected to be substantially lower in the final production well with the use of a wire-wrapped well screen and sufficient development.

- ▶ Total drawdown at the end of the final step was 6.5 m. A production well of similar design to TW1 should have up to 25 m of available drawdown.
- ▶ Recovery following the pump shutting off was rapid, with >95% recovery within 2 minutes.
- ▶ This type of recovery indicates that a majority of drawdown observed was related to well losses and, and that the transmissivity of the aquifer is high.
- ▶ A residual analysis of the recovery data indicated a high aquifer transmissivity (generally associated with high well yields).
- ▶ Testing indicates that a higher pumping rate will be possible with a larger-diameter pump and well.

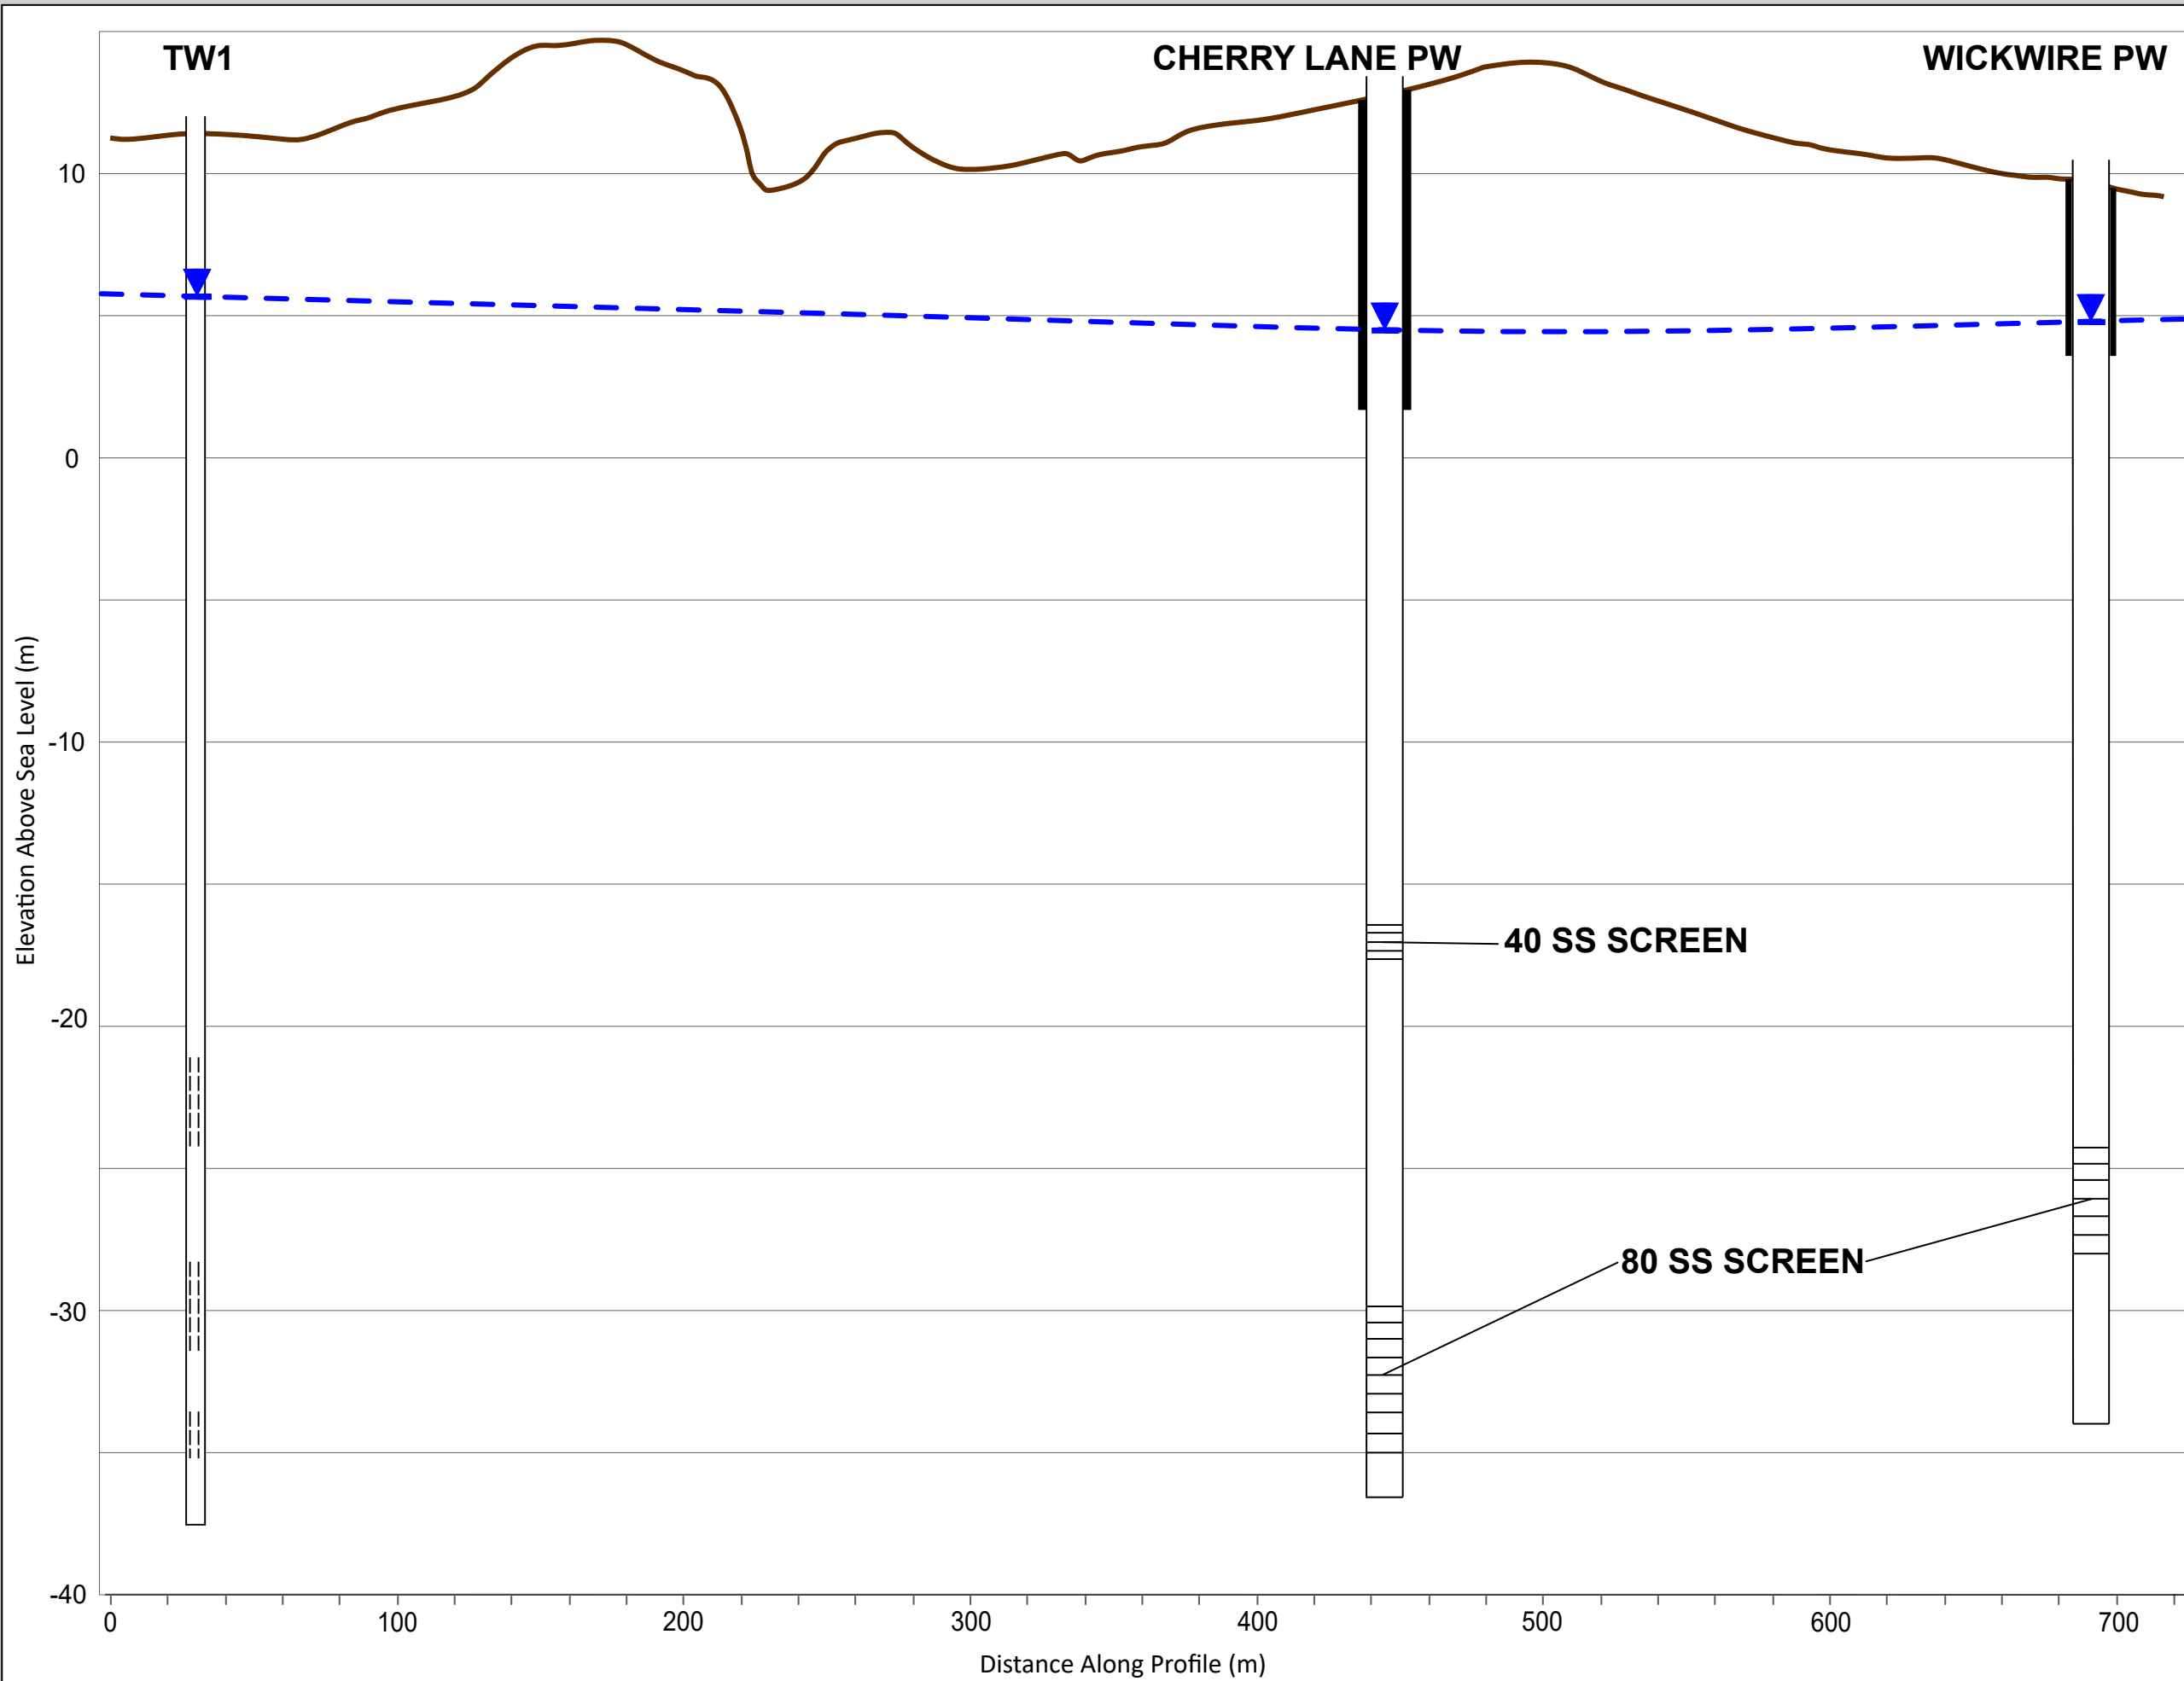
Figure 5 - Production Well Cross Section

Figure 5 shows a cross-sectional profile along the valley axis, comparing the screen depths of the existing production wells and TW1. The recommended screen depths for the new well will be comparable to the existing wells.

- ▶ A 203 mm nominal steel well casing to a minimum depth of 30 m.
- ▶ A manufactured, stainless-steel wire-wrapped screen, with a slot size of 0.080 Inches (80-slot).
- ▶ A 6.1 m screened interval from 33.5 m – 39.6 m.
- ▶ A 1.5 m tight-wind / blank section at the top of the screen and a ~5 m blank section below the screen.
- ▶ A 1.5 m bail-bottom below the screen.
- ▶ A natural filter-pack, developed in place.
